INSPECTION REPORT

Asset ID: POWERLINES

xxx-xxxx-002

Date: 10/12/2024

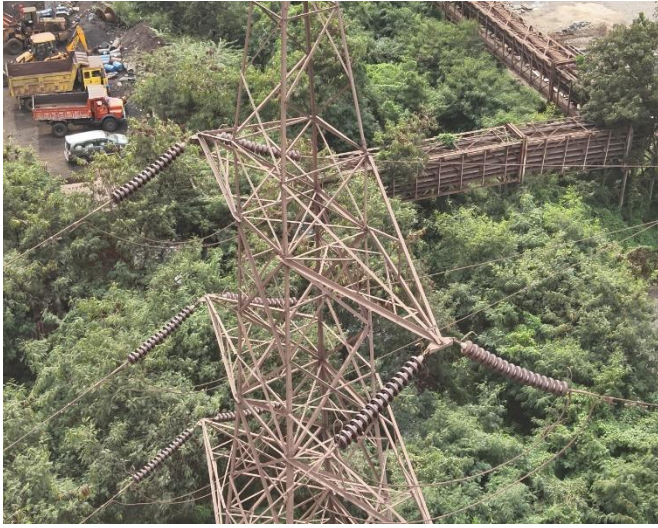
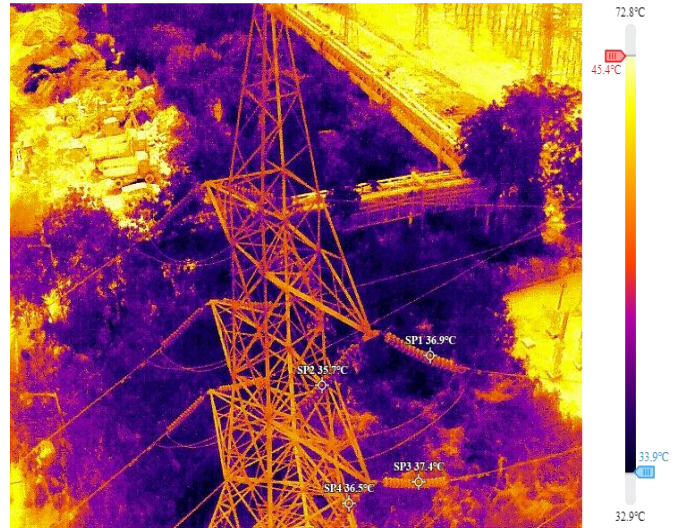
Source Image:	DJI_20241115132854_0002_V&T
Visual Observations: <ul style="list-style-type: none">➤ Rust formation was found on the structure. Thermal Observations: <ul style="list-style-type: none">➤ No anomalies were found.➤ Maximum temperature observed is 37.4°C.➤ Minimum temperature observed is 35.7°C.

1. Rust formation area needs to be painted.

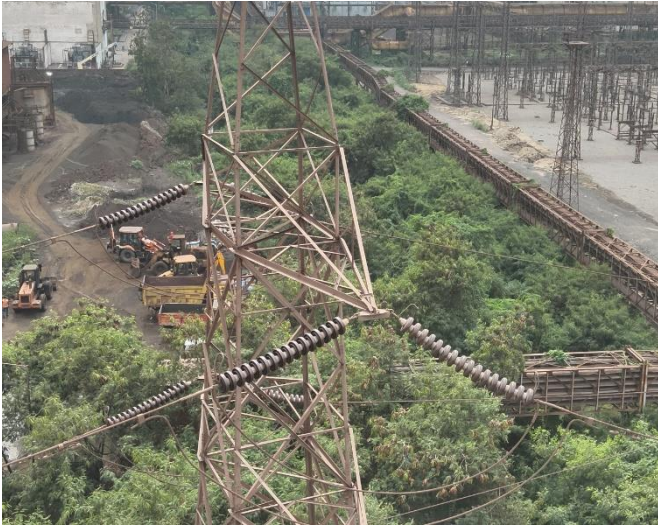
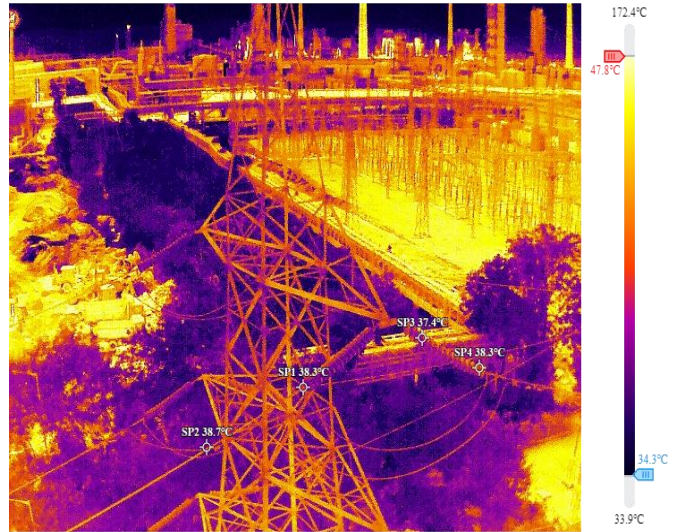
DJI_20241115123746_0003_V&T

- Rust formation was found on the structure.
- No anomalies were found in porcelain insulator.

- No anomalies were found.
- Maximum temperature observed is 38.7°C.
- Minimum temperature observed is 37.4°C.

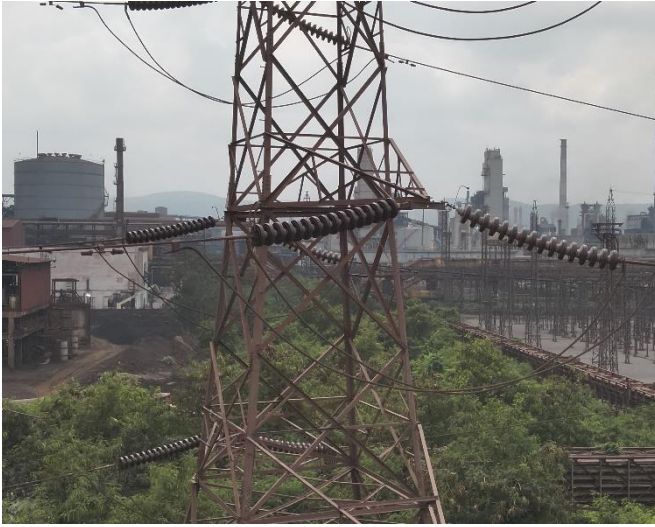
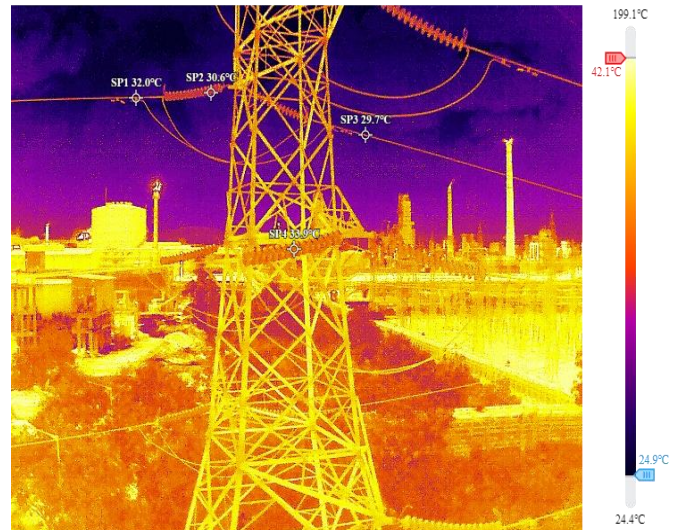
DJI_20241115132943_0007_V&T

- Rust formation was found on the structure.
- No anomalies were found in porcelain insulator.
- No anomalies were found in vibration dampers.

- No anomalies were found.
- Maximum temperature observed is 33.9°C.
- Minimum temperature observed is 29.7°C.

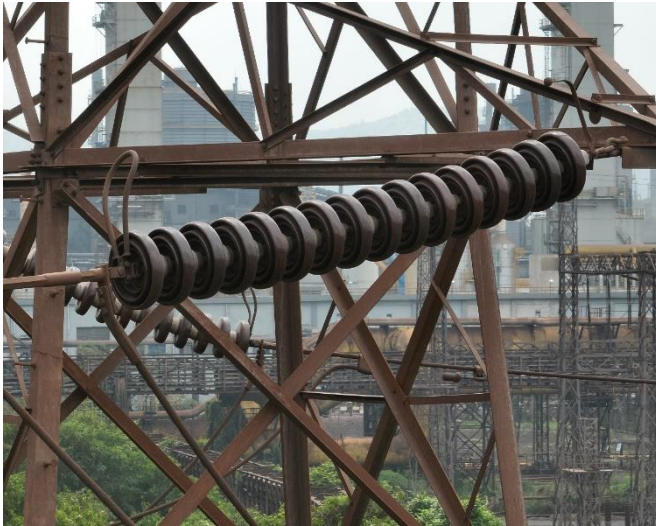
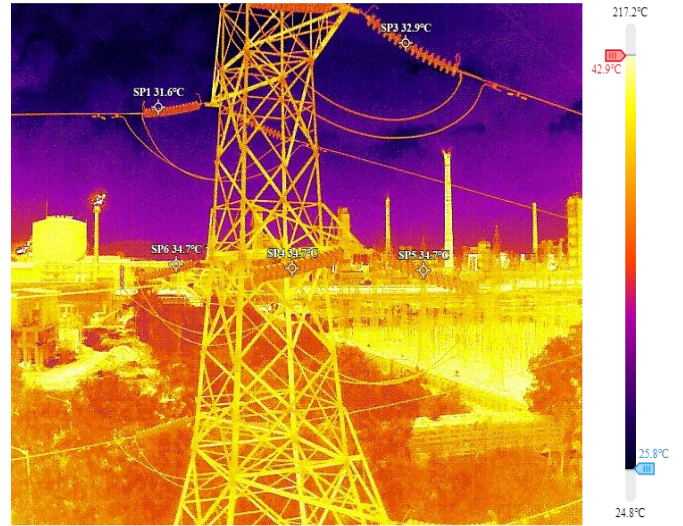
DJI_20241115133009_0009_V&T

- Rust formation was found on the structure.
- No anomalies were found in porcelain insulator.
- Arcing horns were found to be okay.

- No anomalies were found.
- Maximum temperature observed is 34.7°C.
- Minimum temperature observed is 31.6°C.

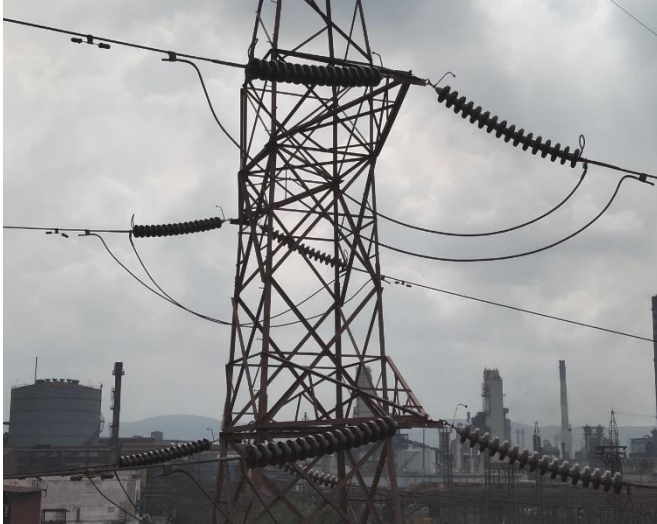
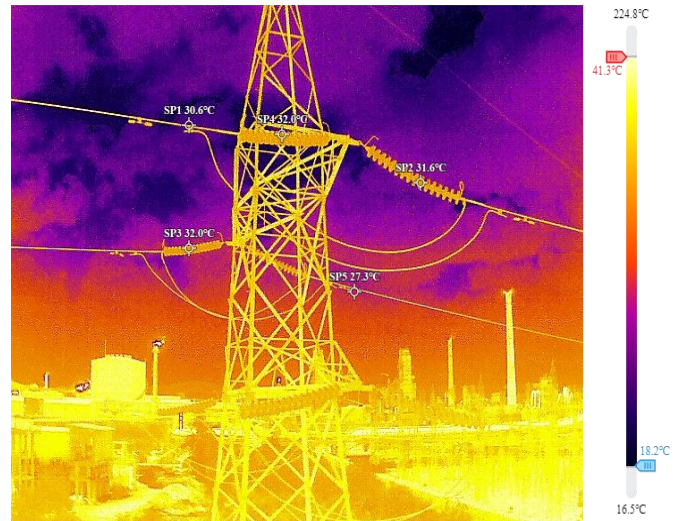
DJI_20241115132937_0006_V&T

- No anomalies were found.
- No anomalies were found in jumper cables.
- Vibration dampers and arcing horns were found in good condition.
- No anomalies found in porcelain insulators.

- No anomalies were found.
- Maximum temperature observed is 32.0°C.
- Minimum temperature observed is 27.3°C.

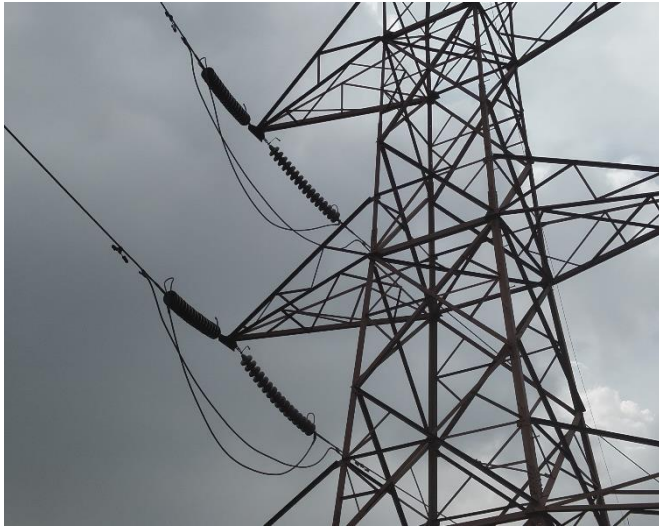
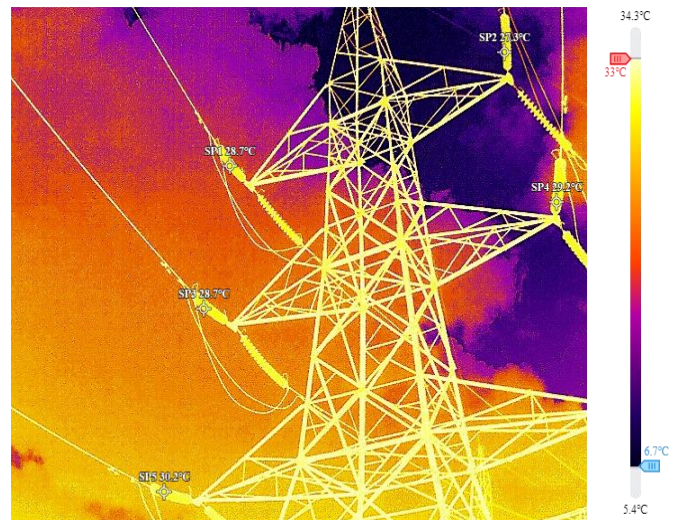
DJI_20241115133738_0019_V&T

- No anomalies were found in jumper cables.
- Vibration dampers and arcing horns were found in good condition.
- No anomalies found in porcelain insulators.

- No anomalies were found.
- Maximum temperature observed is 29.2°C.
- Minimum temperature observed is 27.3°C.
