### Case Study – PrognoSense Electrical Signature Analysis

## Condition monitoring for a centrifugal pump: case study

How Vadict's Electrical signature analysis alerted the customer of stator fault in a motor operated centrifugal pump installed across Tank lorry filling pump house.

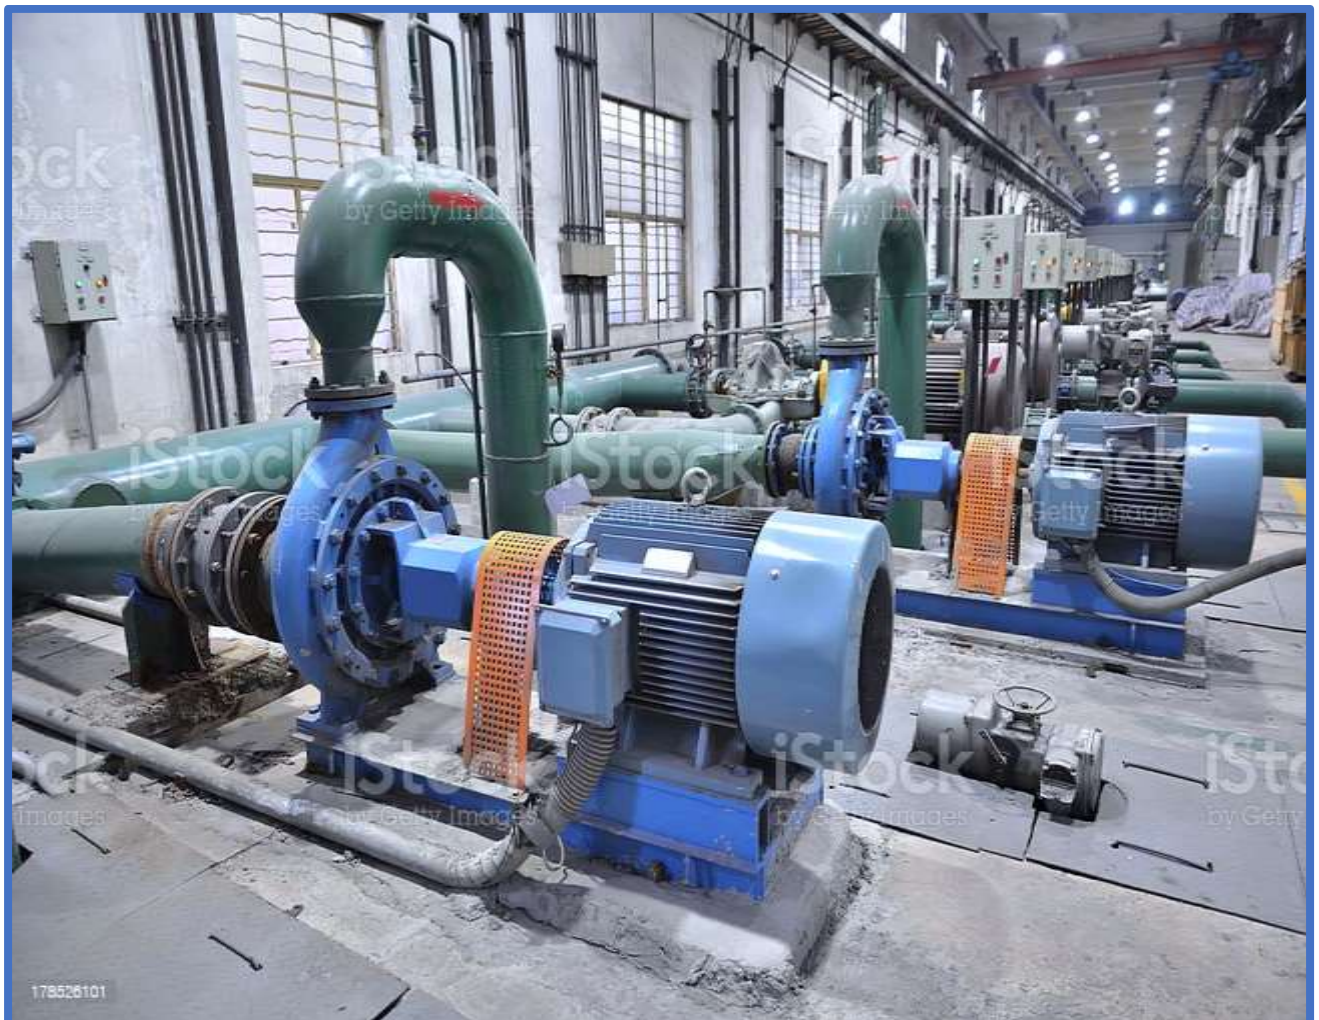
Electrical signature analysis (ESA) is performed when the equipment is online (or "running"). It works on the principle that any variation in the equipment operation will be reflected in the supply voltage and operating current. Thereby, ESA provides the health status of the motor and of the driven load coupled to it.

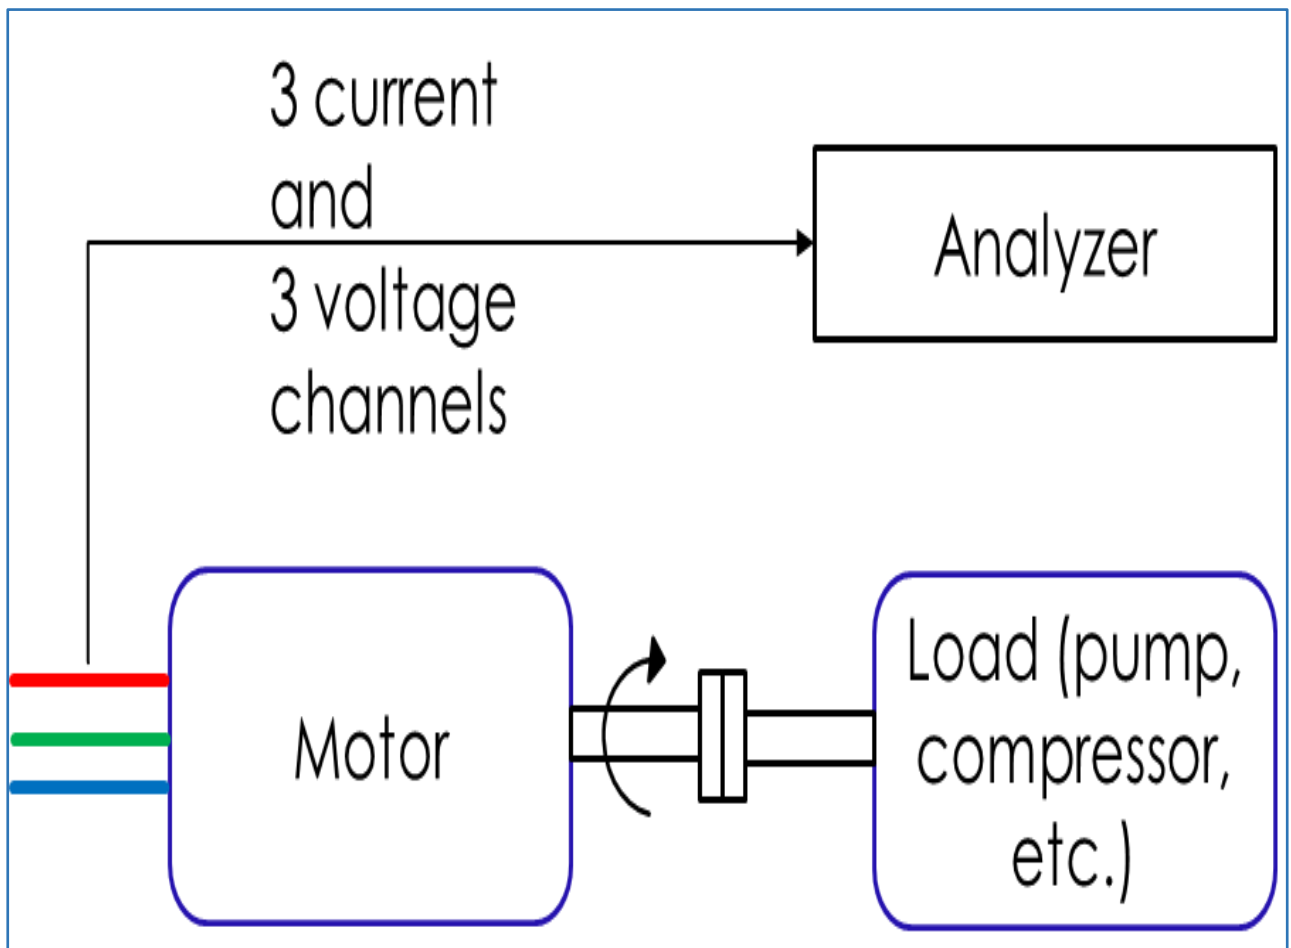
ESA is performed by using current transformers and voltage leads installed in the motor control center. All the three phases of current and voltage are captured at a high resolution to monitor the health of the machine. The time domain data is converted to frequency domain to obtain the constituent frequencies present in the signal. Waterfall plots are also generated to visualize the variation of parameters over time. The solution provides insight into the mechanical and electrical faults associated with the motor load system.

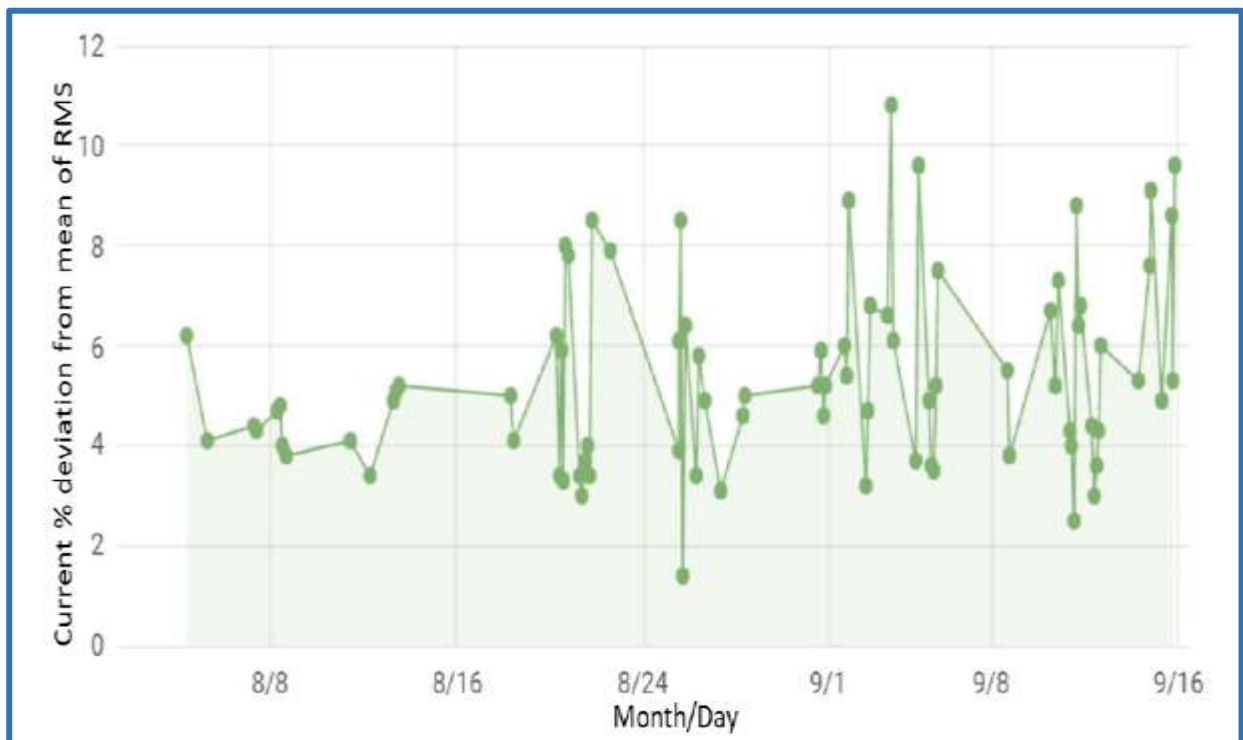
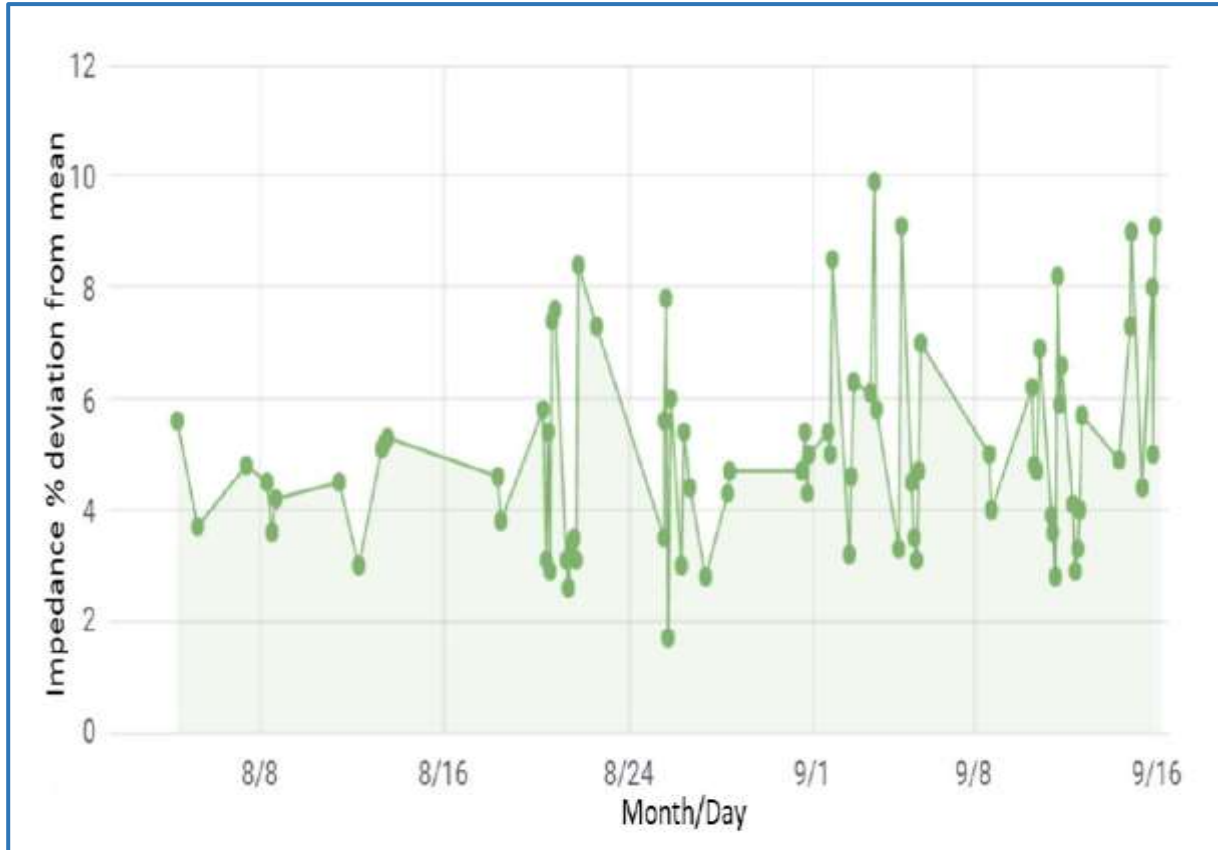
A 45 kW VFD-driven centrifugal pump indicated the development of a turn-to-turn fault.

The online results of high current and impedance unbalance, accompanied by comparable magnitudes, resulted in alerting the user of problematic internal coil connection. The software reports it as a turn-to-turn fault. The unbalance levels of current and impedance were evaluated for operational load above 40%.

During the scheduled maintenance window, customer discovered degraded stator winding. Corrective action was carried out by rewinding the motor coil.
